2006 Annual Site Inspection and Monitoring Report for Uranium Mill Tailings Radiation Control Act Title II Disposal Sites

November 2006

Work Performed by S.M. Stoller Corporation under DOE Contract No. DE-AC01-02GJ79491
for the U.S. Department of Energy Office of Legacy Management, Grand Junction, Colorado

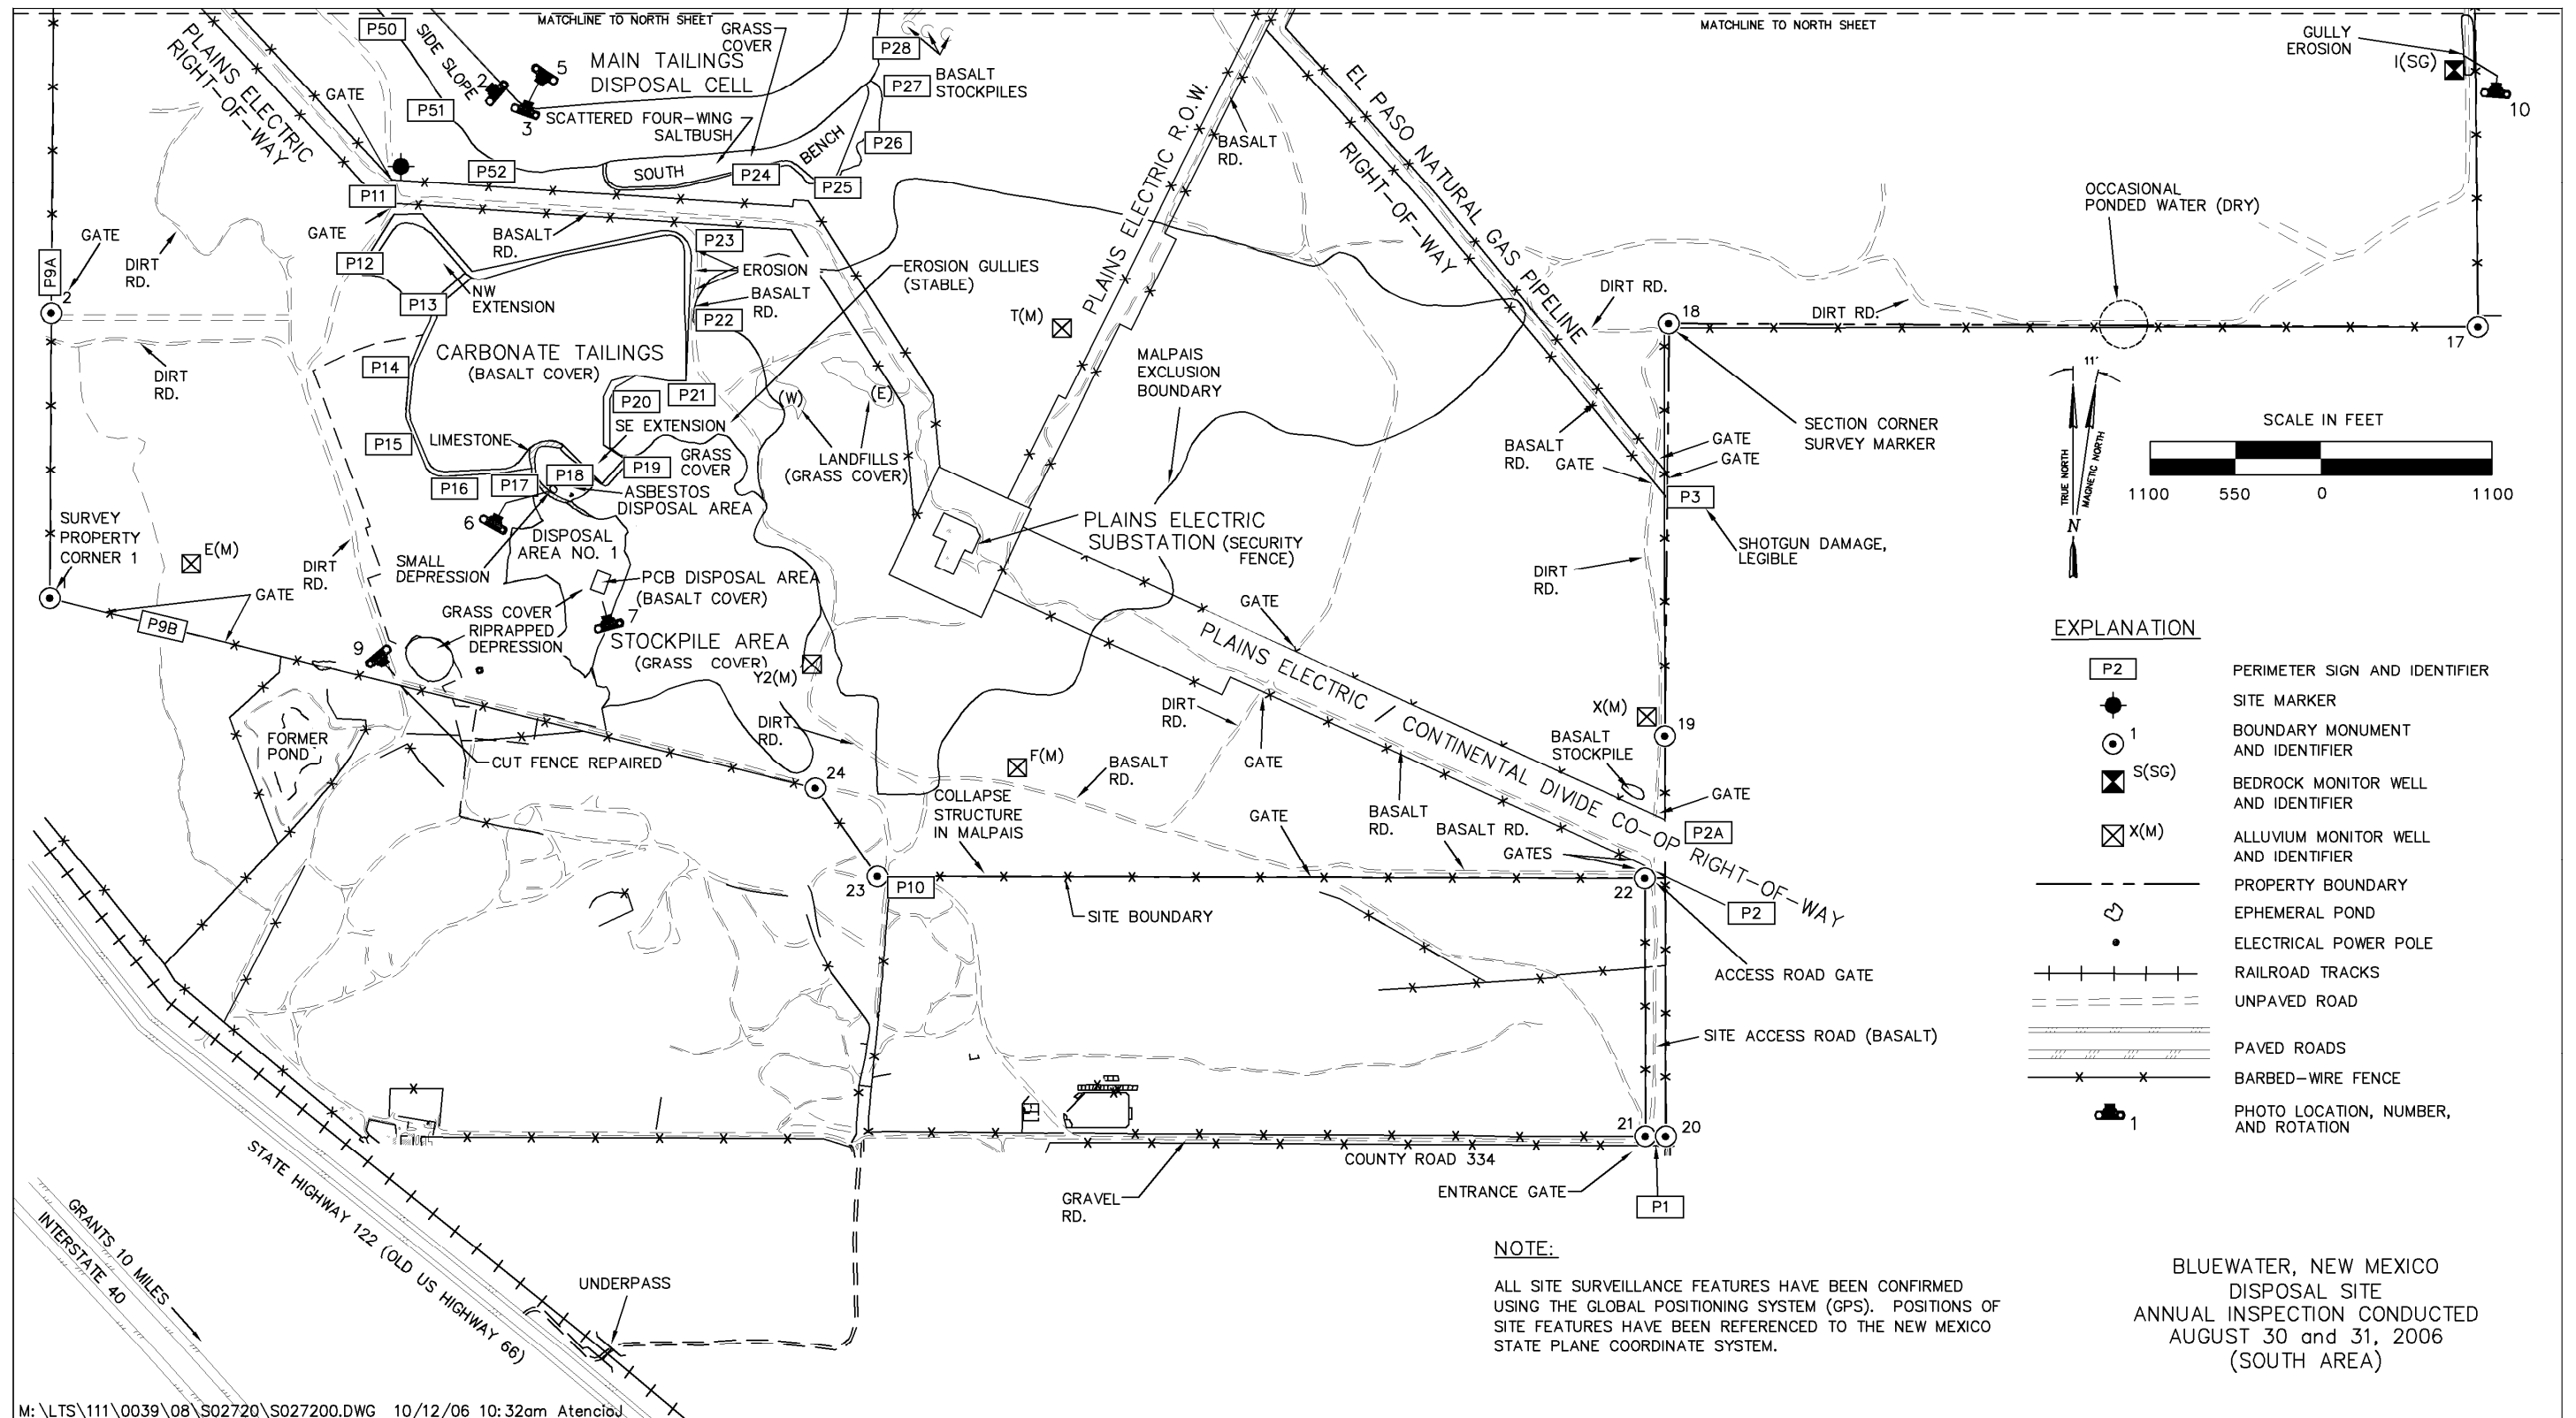
Figure 1-1. 2006 Annual Compliance Drawing for the Bluewater, New Mexico, Disposal Site (South Area)

Fifty-five warning signs, designated as perimeter signs P1 through P52 on the drawings (including perimeter signs P2A, P9A, and P9B), are mounted on steel posts at access points along right-of-way intersections within the site boundary and around the main and carbonate tailings disposal cells. Perimeter sign P3, damaged by a shotgun blast, is still legible. All other signs were in good condition.

Main Tailings Disposal Cell, the Acid Tailings Disposal Area, and the South Bench Disposal Area—These three disposal areas are contiguous and together constitute one large disposal area of approximately 320 acres; all were in excellent condition. The main tailings disposal cell is covered with basalt riprap and slopes northward. The top slope grade decreases from 3 to 4 percent at the south end to less than 0.5 percent at the north end. The top slopes of the acid tailings (PL-1) and the south bench disposal areas are essentially flat and covered by healthy grass. The side slopes of the three disposal areas are protected by basalt riprap (PL-2). The riprap was in excellent condition.

Several small shallow depressions exist on the relatively flat north end of the top slope of the main tailings disposal cell. Although ponded water has been observed in the past, the depressions were dry at the time of the inspection. Slimes from the settling ponds were placed in the northern part of the main tailings disposal cell and areas containing slimes are more likely to settle than areas containing drier waste materials. One depression appeared to be deeper than observed during the 2005 inspection (PL-4). The depressions will continue to be monitored for evidence of significant settling or displacement. Given that evaporation greatly exceeds precipitation in this area, ponding is believed to be infrequent and brief and, therefore, is not a concern.

Desiccation cracks are present in the soil adjacent to the northeast corner of the main tailings disposal cell. The features are caused by shrinkage of clay-rich backfill materials and do not impact the stability of the cell. Small ponds often form in an area along the east side of the disposal cell following storm events. Standing water was present at the time of inspection. The areas of ponding are far enough from the cell to not impact it.

1C The asbestos disposal area is a bowl-like feature or depression just south of the carbonate pile. The north, west, and south side slopes of this depression are covered by limestone riprap; the bottom of the bowl is grass covered. A small depression is located along the south edge of the disposal area, and could represent piping or collapse of uncontaminated fill material incompletely compacted during final grading (PL-6). The depression was first noted during the 1999 annual inspection but has not been a concern because it does not encroach on asbestos-containing materials. However, to mitigate the potential for encroachment into these materials, the depression is scheduled to be filled with crushed basalt rock in 2007. Potential access routes to haul crushed rock to the disposal area were investigated. Other than the depression, the disposal area is in excellent condition.

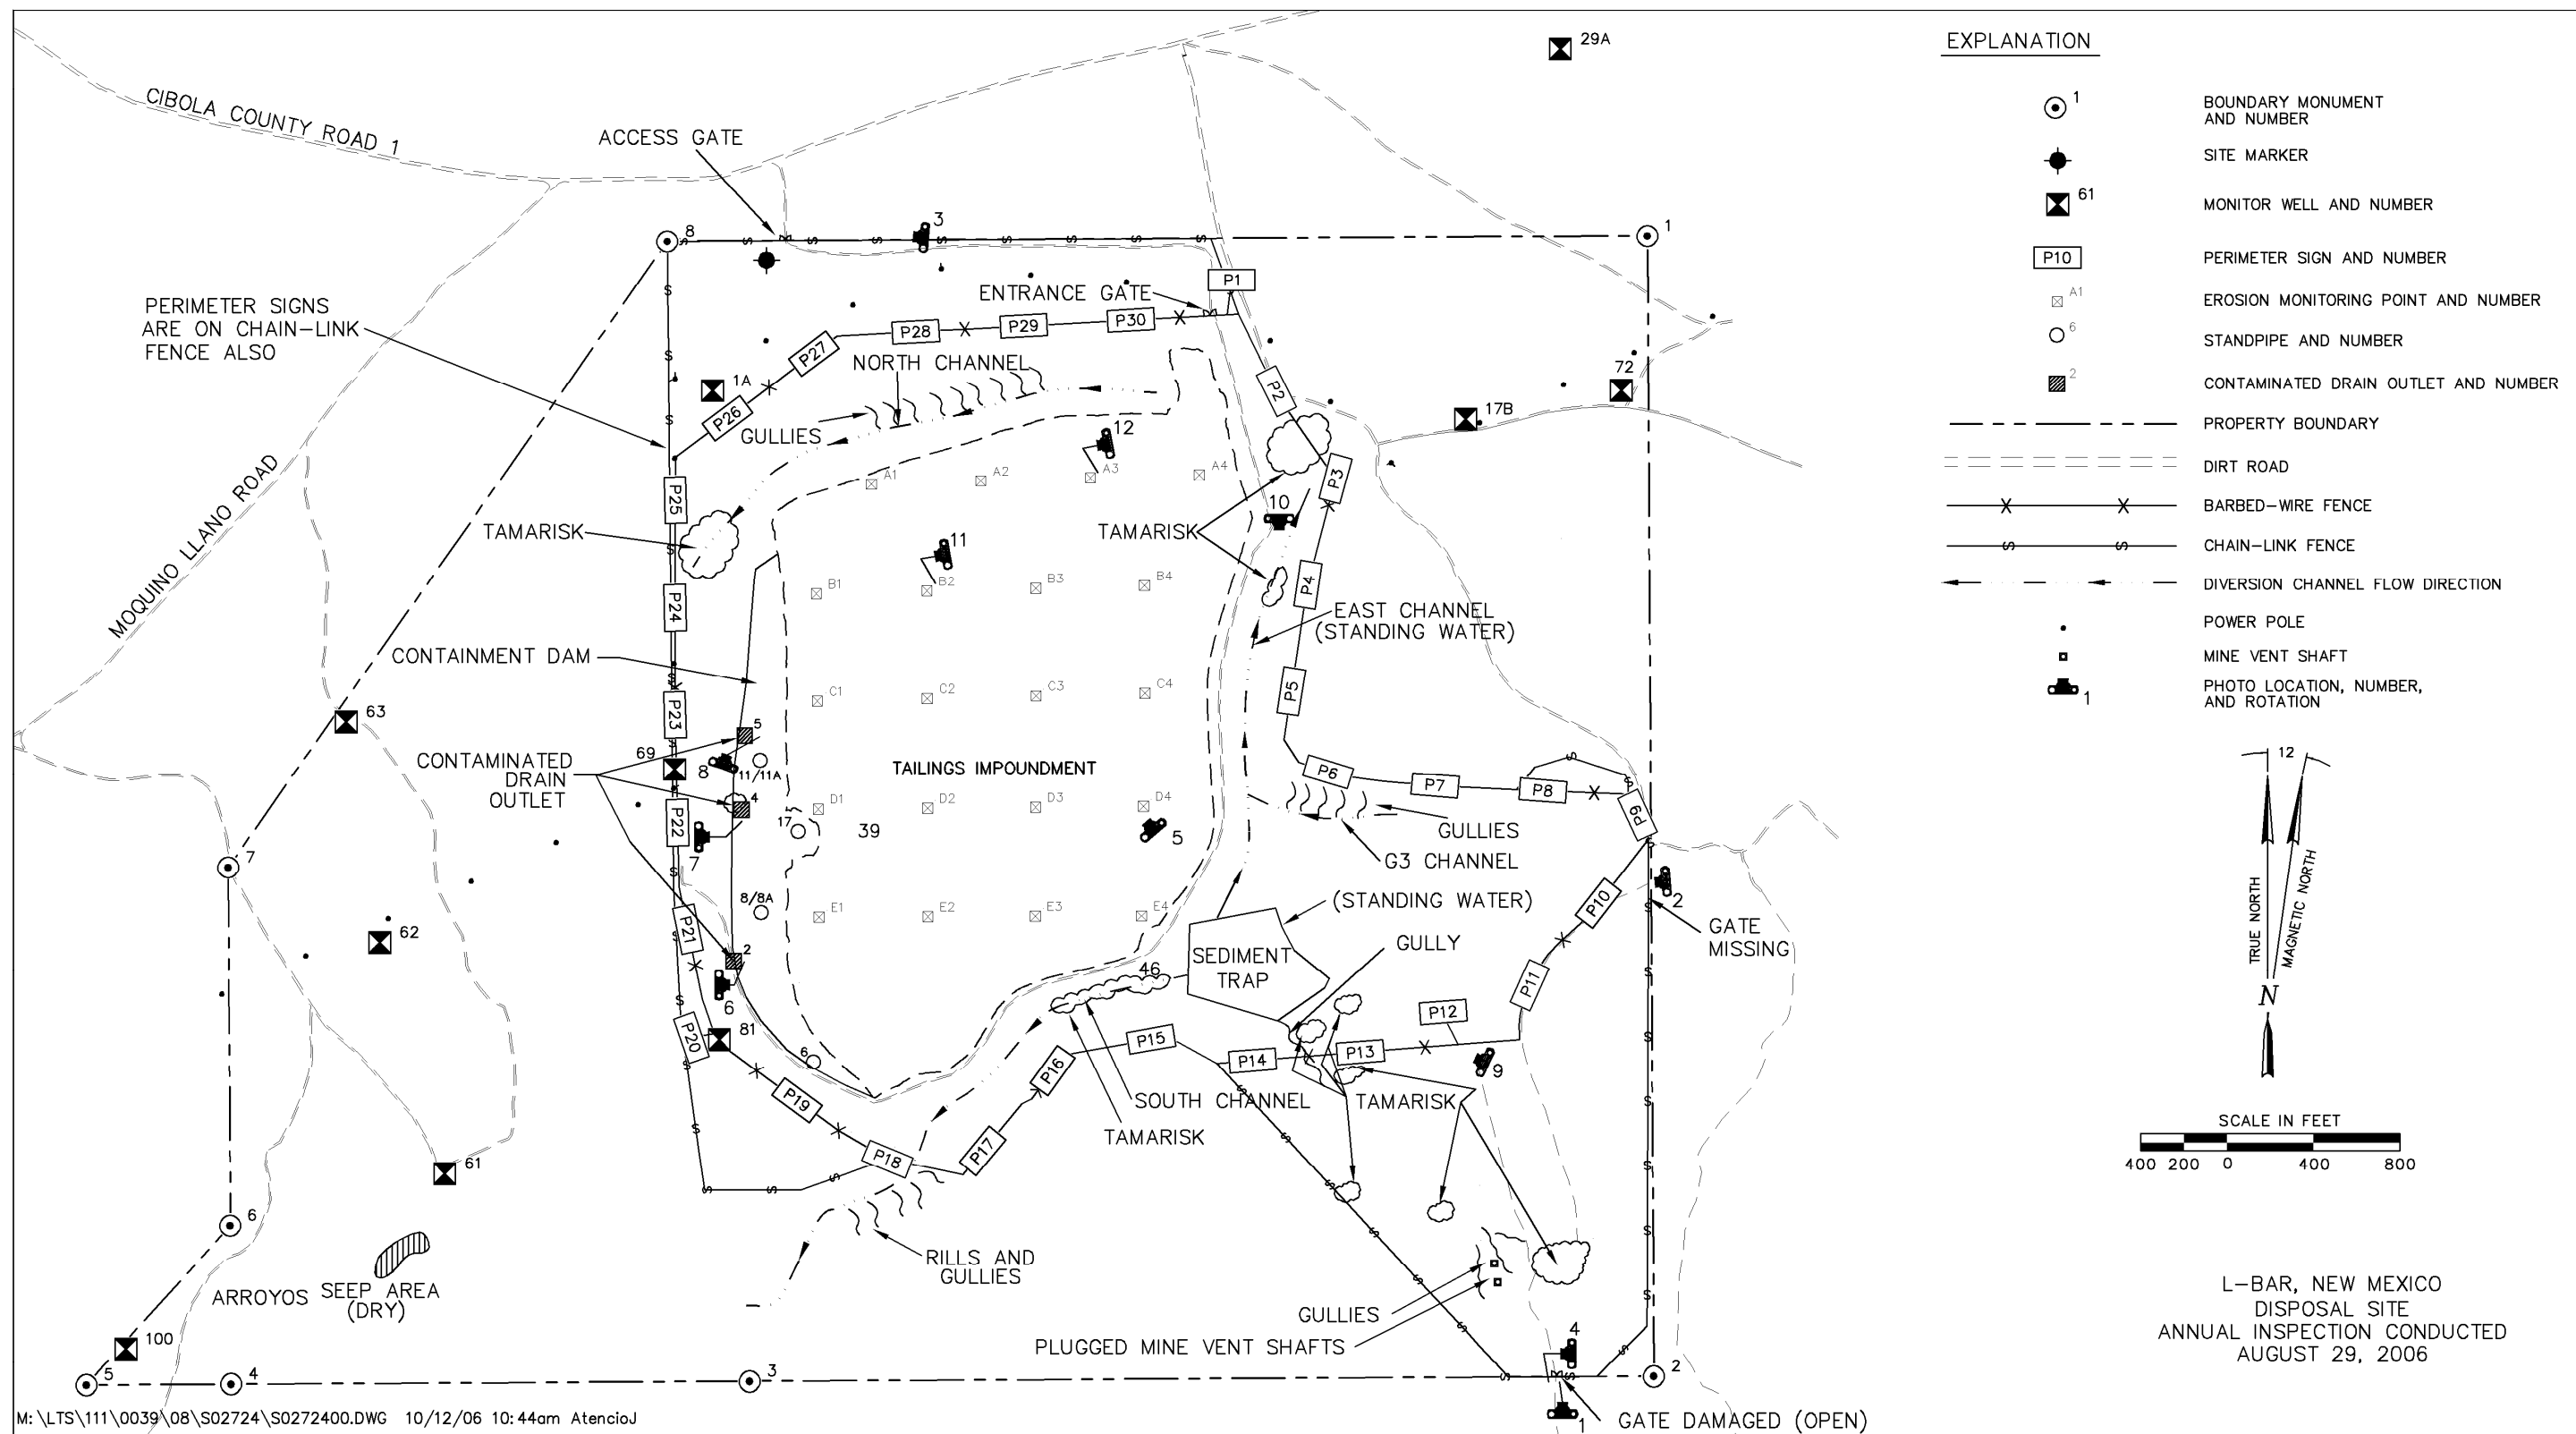
Figure 3-1. 2006 Annual Compliance Drawing for the L-Bar, New Mexico, Disposal Site

Site Markers and Boundary Monuments—The granite site marker, located immediately inside the access gate, was in excellent condition. Eight flush-mounted boundary monuments installed at property tract corners are in excellent condition.

Monitor Wells—The site ground water monitoring network consists of ten wells. Nine of the wells are located on the DOE site; background monitor well MW–29A is located outside the northeast corner of the site. Some well locations do not have established access roads or tracks but are accessible by 4-wheel drive vehicle as long as the ground is dry. Each well was inspected and was secure and in good condition.
